[Docket No. 98-CE-01-AD]

Airworthiness Directives; Maule Aerospace Technology Corp. M-4, M-5, M-6, M-7, MX-7, and MXT-7 Series Airplanes and Models MT-7-235 and M-8-235 Airplanes

ACTION: Notice of proposed rulemaking (NPRM).

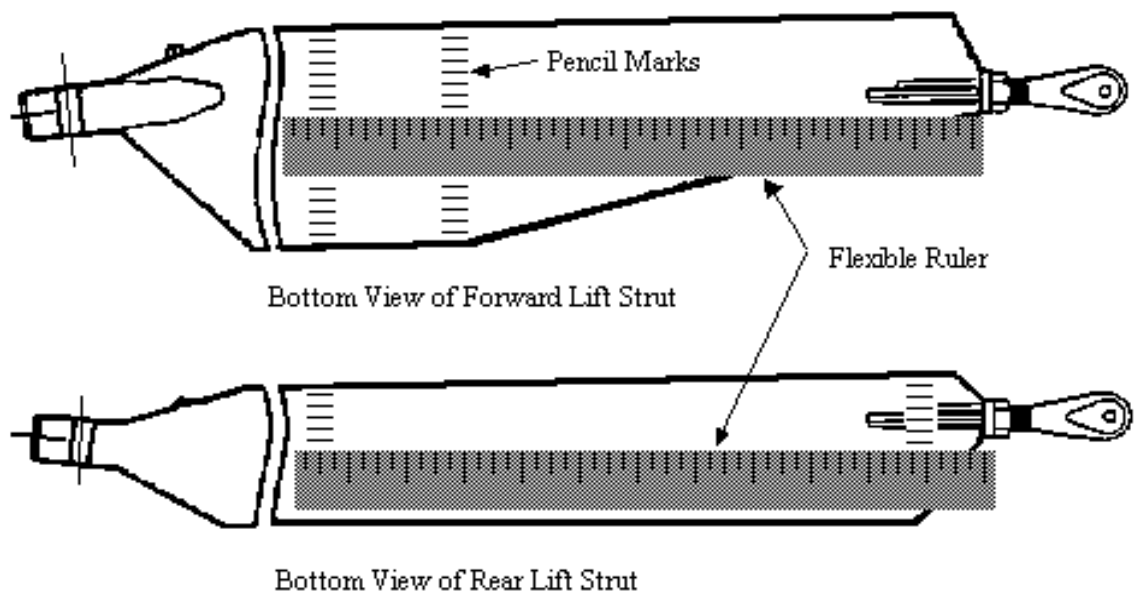
**Figure 1**

2. Using a flexible ruler, draw a 1/4-inch grid on the surface of the first 11 inches from the lower end of the strut as shown in Piper Service Bulletin No. 528D or 910A, as applicable. This can be done using a soft (#2) pencil and should be done on both faces of the strut. As an alternative to drawing a complete grid, make two rows of marks spaced every 1/4 inch across the width of the strut. One row of marks should be about 11 inches from the lower end of the strut, and the second row should be several inches away where the strut starts to narrow. Lay the flexible ruler between respective tick marks of the two rows and use tape or a rubber band to keep the ruler in place. See Figure 1.
